Welded Steel Moment Resisting Frames

The Earthquake-Resisting System that Surprised the Profession

By Ronald O. Hamburger, S.E., and James O. Malley, S.E.

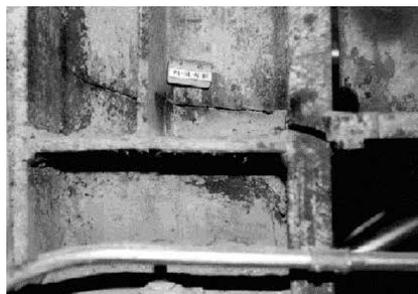
One of the first discoveries of damage was at the Getty Art Museum, a WSMF structure then under construction in the hills between West Los Angeles and Sherman Oaks. Workers returning to the site observed strange cracks (fractures) in the still exposed steel moment connections. Then, an engineer performing a post-earthquake inspection of the Santa Clarita City Hall was surprised when a fractured bolt fell on his head when he opened a ceiling. Removal of fireproofing revealed similar cracking in that building's connections. Engineers observed that the U.S. Borax Corporation headquarters building in Valencia and the nearby Southern California Automobile Association Building (Figure 3) had large, permanent interstory drift and found fractured connections in those buildings as well. Fracture patterns varied. In some cases, the fracture severed the welded bottom beam-flange-to-column-flange joint. In others, the fracture progressed into the column flange, forming a loose divot of column flange material. In a limited number of other cases, the fracture propagated into the column and across the column web (Figure 4). In some cases, bolted web connections also failed, shearing bolts or fracturing shear tabs.

Figure 4. Fracture extending from CJP weld across column web.

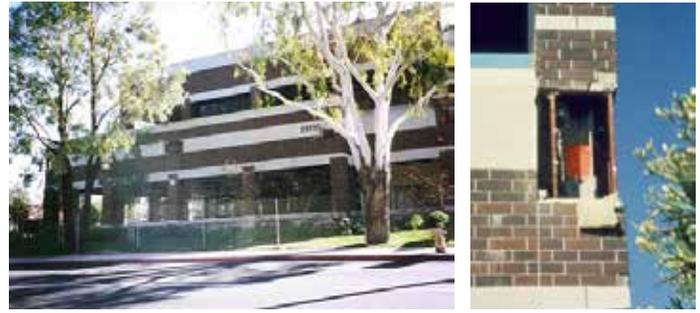
Figure 3. The Southern California Automobile Association Building. To the right, a large permanent drift in the building.
