# To Repair or Replace: Structural Assessment of Damage at the Steeplechase Pier

BY KIRK M. STAUFFER, STEVEN D. HALL, AND KEVIN C. POULIN

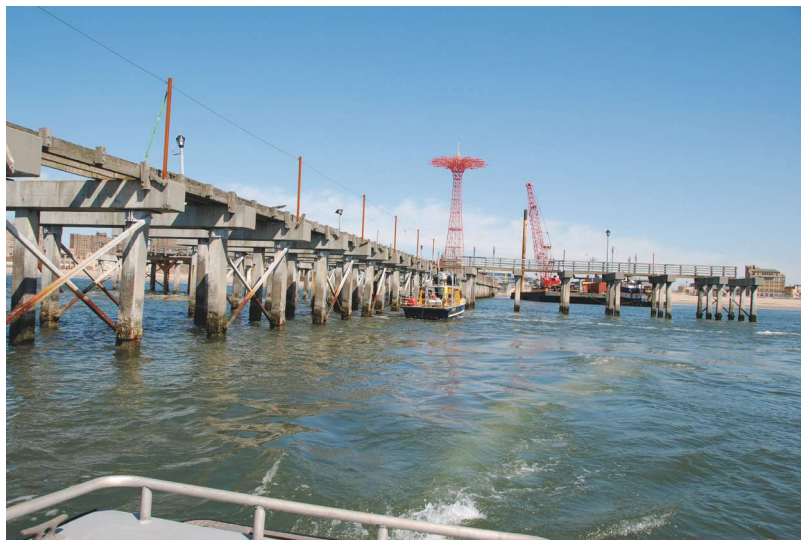
Steeplechase Pier suffered extensive damage to the wood decking and framing, but the concrete frames (piles and beams) emerged from the storm relatively unscathed. The storm surge and waves displaced, detached, or completely removed the wooden decking and framing throughout the pier. The post-Sandy repair scheme for the pier consisted of completely removing and rebuilding elements of the structure atop the existing precast concrete frames.

Fig. 2: Overview of pier construction (some existing wood decking and framing remains)

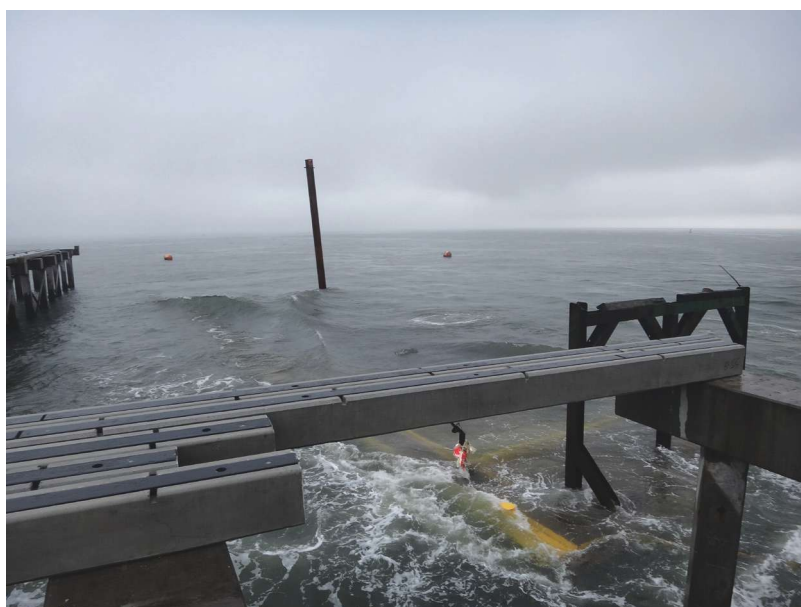
On April 12, 2013, a construction barge that was stationed adjacent to the southern tip and west extension of the pier suffered a failure of the “spud” mooring system and began to take on water in rough seas. The barge began to sink and rotate horizontally on the water surface and list (tilt), with the southern end of the barge sinking and the northern end raising up. By April 14, 2013, the majority of the barge had submerged. The sinking, rotating, and listing combined with wave action from rough seas caused the barge to impact the pier at two locations—one at the southern tip and one at the west extension. By April 17, 2013, the barge had completely sunk away from the pier and came to rest on the mudline below (Fig. 3).

Fig. 3: View of completely-submerged barge (the submerged barge came to rest away from the pier)

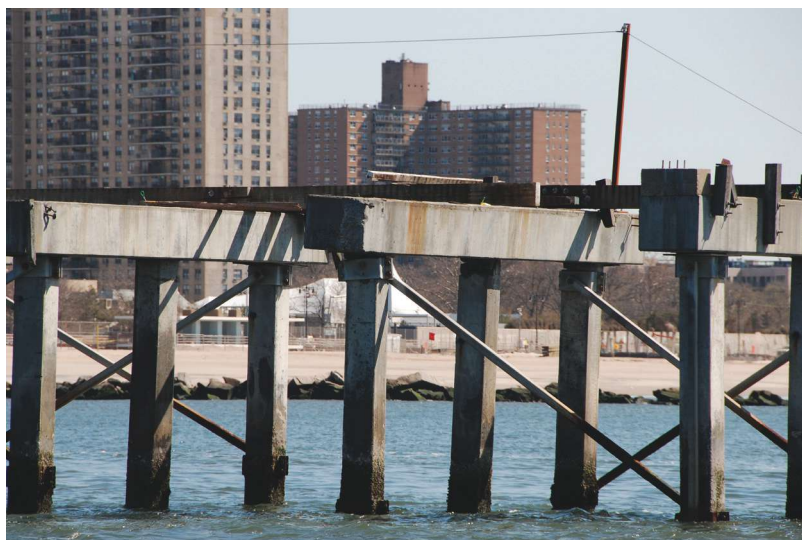
Fig. 4: View of rotated beam at southern tip of pier

southern tip), the entire frame assembly was displaced at the top (as seen with the naked eye) from its original position. At all three locations, the impact of the barge imparted large lateral forces on the frames, resulting in lateral displacement and shear failures of the piles in a zone directly below the beam. Large horizontal cracks running completely through the pile cross-section, along with associated concrete spalling and lateral displacement across the pile axis, provided evidence of shear failures. The condition of the piles below the waterline remained unknown (Fig. 4 through 6).

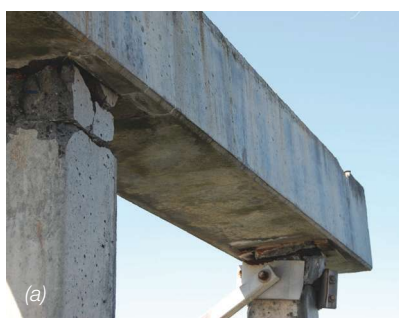
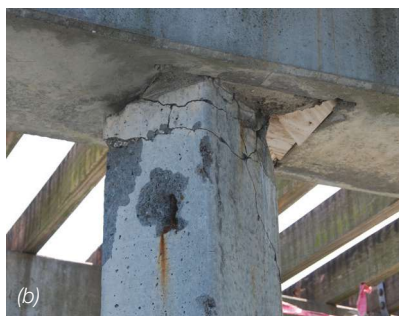
On April 15, 2013, the damage that was readily apparent above the waterline was observed and documented. The observations were made from atop the remaining portions of the pier deck and from the top of the partially submerged barge that had temporarily stabilized in calm seas. The barge had severely damaged three of the typical three-pile frames. The damage to the piles immediately below the beams was severe and plainly visible.

Fig. 5a & b: Views of (typical) shear failures at piles

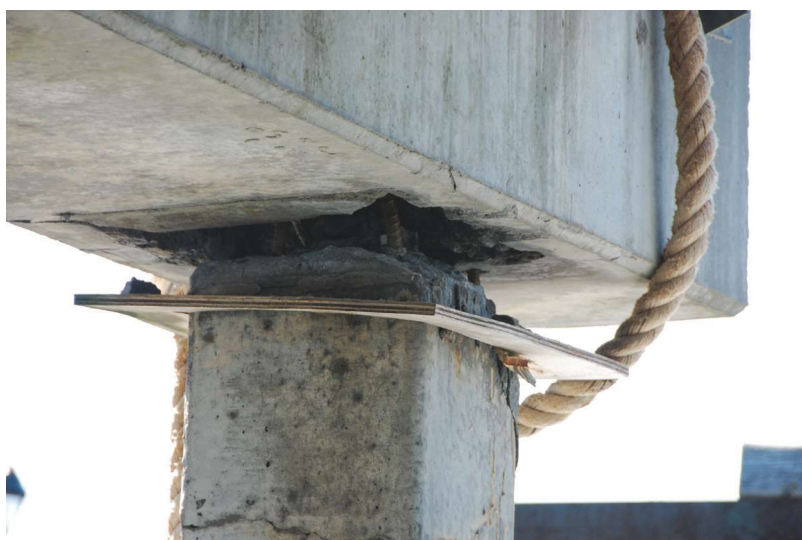
The barge lifted one of the beams at a frame at the west extension of the pier. At the other two frames (one at the west extension and one near the

Fig. 6: View of lifted beam at west extension of pier

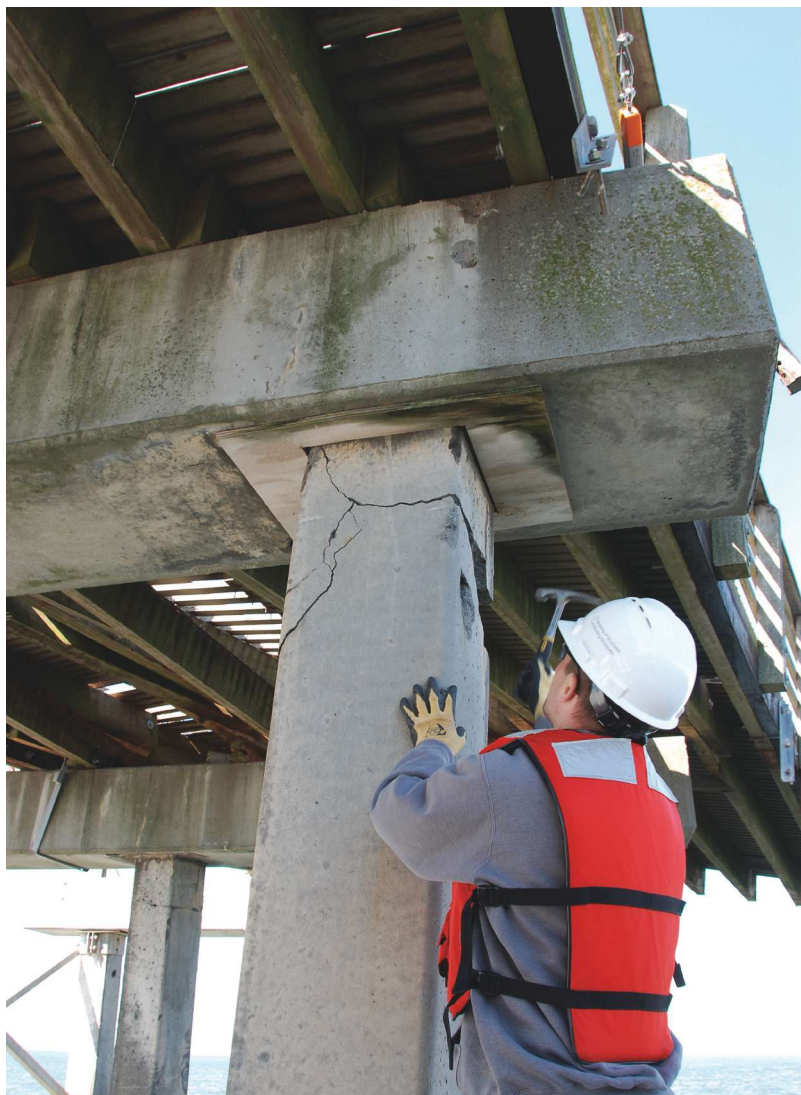
Poor weather and difficulty finding an appropriate boat that could navigate between the piles delayed the investigation until April 25, 2013. While on site, the boat was positioned between and against the piles, making hands-on surveys possible from the deck of the boat. Ground penetrating radar (GPR) determined the locations and typical configurations of reinforcement. GPR results were confirmed, along with the sizes of reinforcement, at the concrete spalls caused by the barge impact. Portions of the piles accessible above the waterline were also sounded to survey for damage or delaminations not visually apparent. This hands-on survey from a boat indicated that significant distress to the piles above the waterline was only at the plainly-visible distressed zones (Fig. 7 and 8).

Fig. 7: Sounding at affected piles

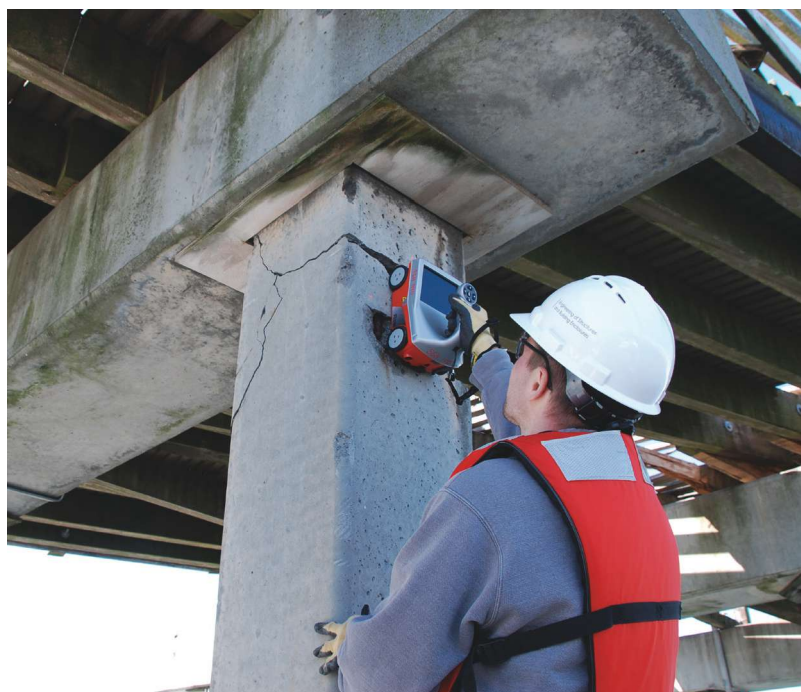
Fig. 8: Ground-penetrating radar (GPR) at affected piles

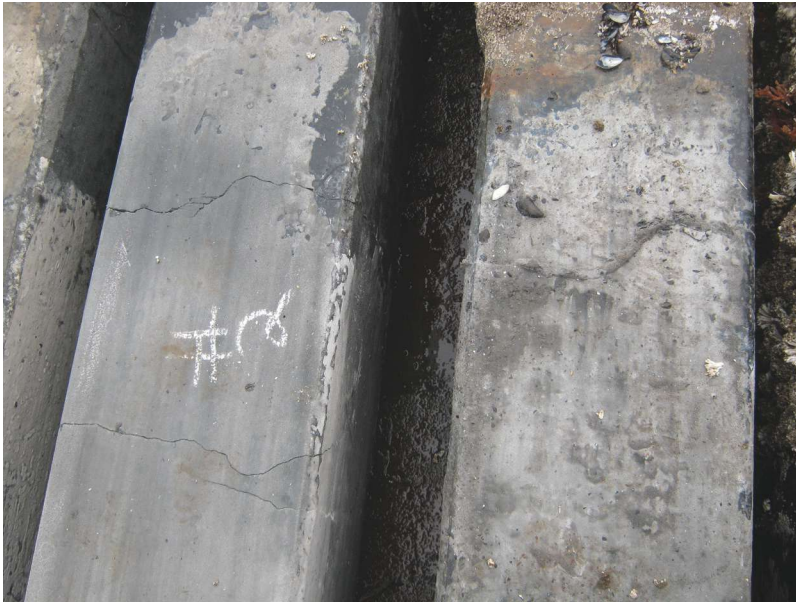
Fig. 9: View of damage to affected piles, after removal, below mudline

of the existing piles would be selectively demolished and the stub piles would be connected to the existing piles to transfer only shear and axial loads. This initial repair design would effectively shorten the length of the existing piles and upgrade the pile-beam connection from a pinned connection to a full-moment connection. Development of this repair design stopped shortly after an existing pile tipped following removal of the beam. Following the pile failure, and as directed by the owner, the contractor removed and surveyed the affected piles on a barge. At previously-unseen areas below the mudline, the piles exhibited notable damage, such as cracking through the full cross-section, further confirming that the initial repair design would not correct all of the damage (Fig. 9).

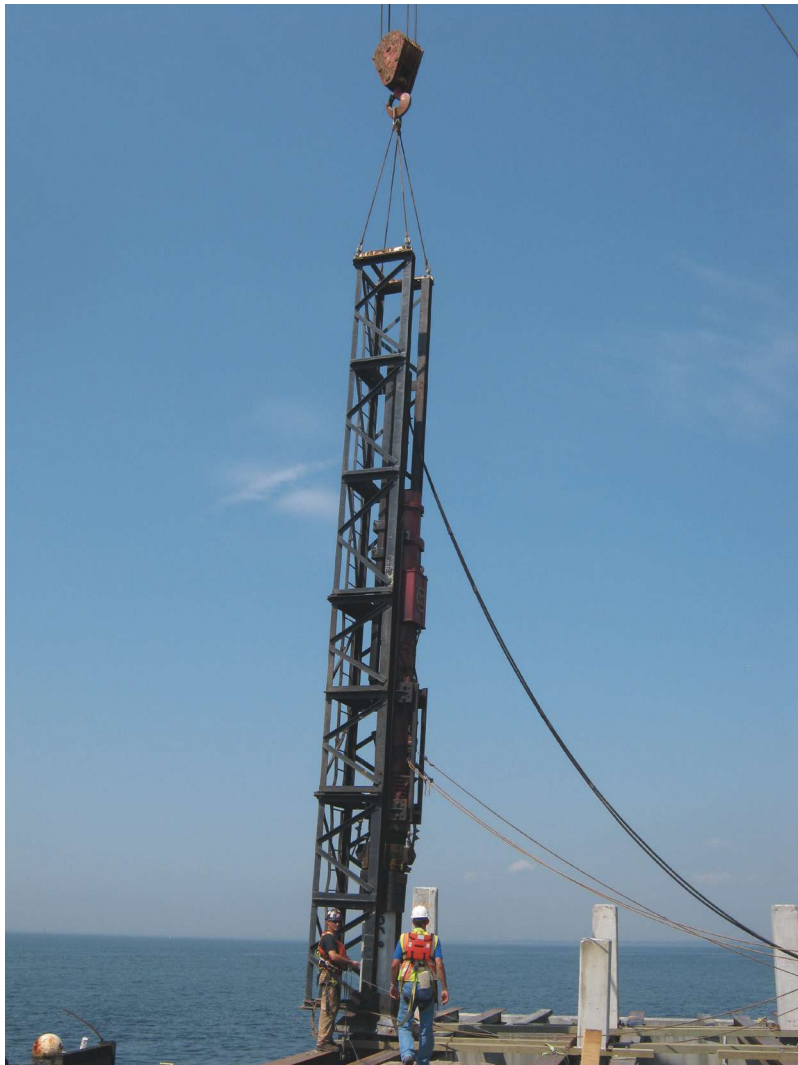
Fig. 10: Overview of driving new replacement pile

New piles and beams were fabricated during removal of the existing piles. Generally, the new piles and beams were designed to be identical to the existing. However, by modifying and implementing some of the detailing planned for use in the initial repair scheme, a precast concrete solution was created to develop the full flexural strength of the new piles at the connection to new beams. The connection used couplers at the end of four threaded No. 10 bars which were cast into the top of each pile. After driving the pile (Fig. 10) and demolishing the tops of the piles to the same elevation, the threaded bars were carefully exposed and couplers used to connect stub lengths of threaded No. 10 bar up through the beam, terminated with nuts and washers atop anchor plates located within the beams. Each pile-to-beam connection was then grouted together using a rapid-strength-gain repair mortar on site, following assembly (Fig. 11 through 13).

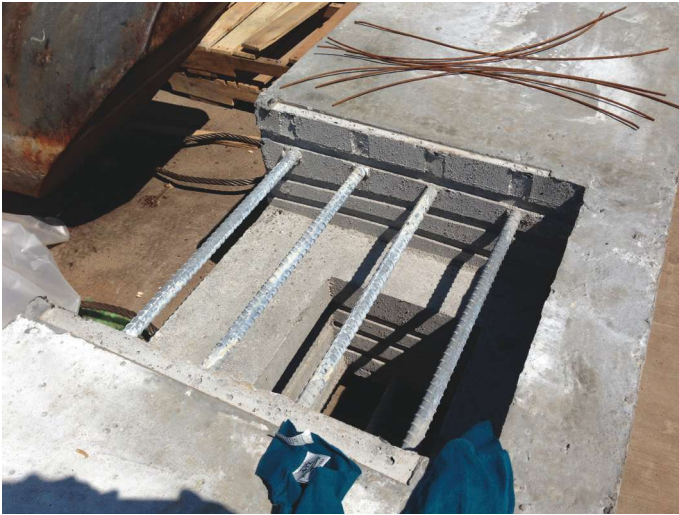
Fig. 11: Pile-beam connection prior to assembly

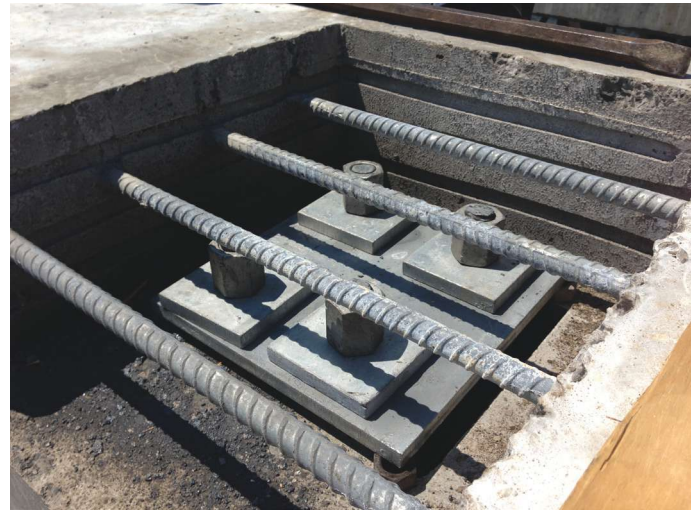
Fig. 12: Pile-beam connection after installation of threaded bars, couplers, plates, washers, and nuts

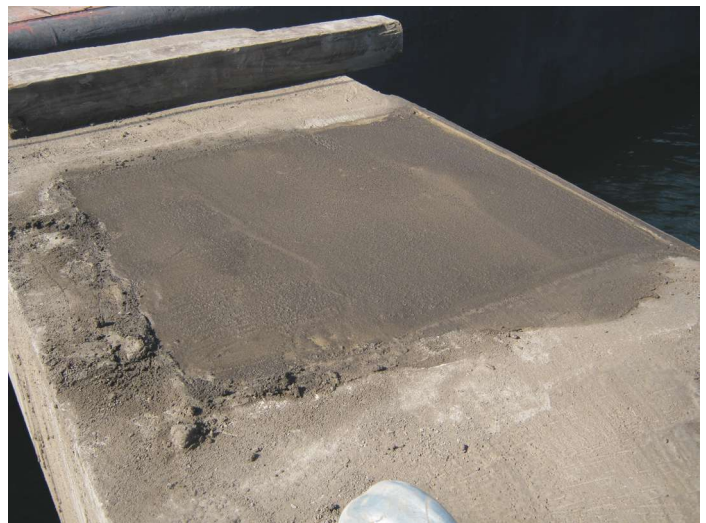
Fig. 13: Pile-beam connection after grouting with rapid-strength-gain repair mortar
