# EIFS: PRINCIPLES AND CONSIDERATIONS

By Eric Olson

20 NOVEMBER 2017

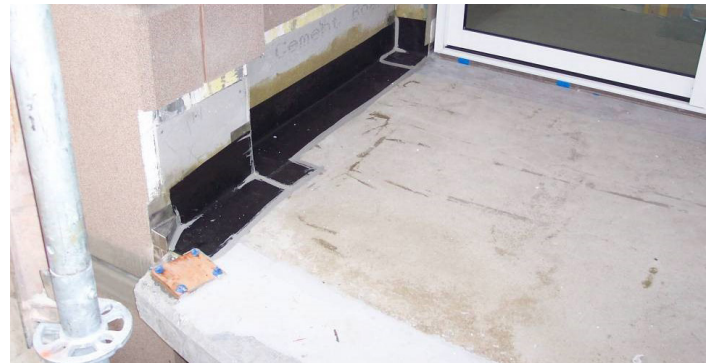
Balcony transition to EIFS wall retrofit with watertight flashing.

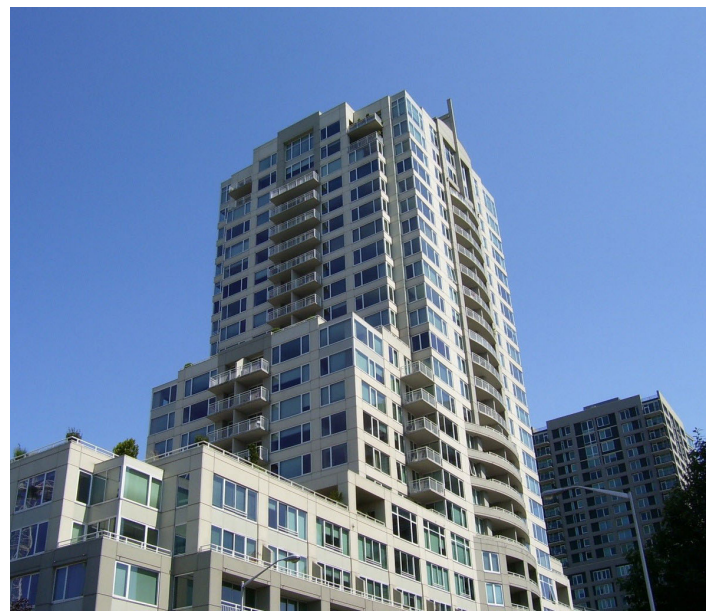
High-rise, barrier EIFS-clad condominium building retrofit with new windows, sealants, flashings, and waterproofing systems at critical transitions to successfully correct water intrusion issues.

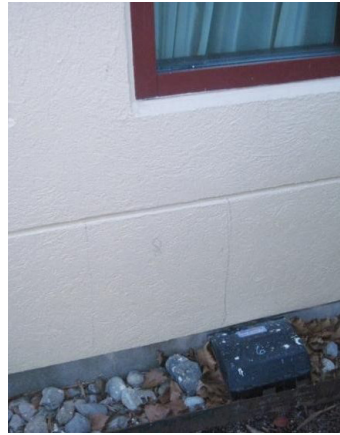
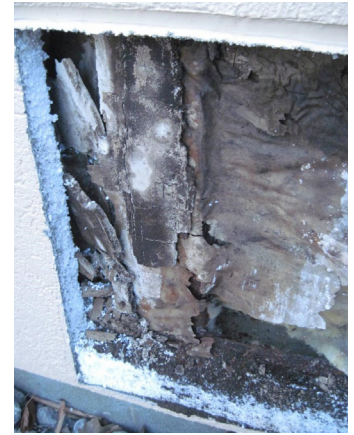
Barrier EIFS at wall base (left). Despite its clean, recently painted appearance, sampling at this location reveals substantial water damage to the wall sheathing and steel framing behind (right).

Earlier EIFS applied directly to wood, paper-faced gypsum, or masonry substrates are often referred to as barrier EIFS. Barrier EIFS has no water-resistive barrier or flashings behind the insulation layer. Instead, barrier EIFS relies on the lamina and sealant between the EIFS and other facade components (e.g., windows and doors) to stop water from penetrating the facade. In practice, achieving and maintaining a watertight EIFS and sealant barrier is difficult. Water penetrating cracked EIFS, sealant failures, or other leaky facade components can enter the wall system. Without a drained water barrier and flashings, this water becomes trapped, where it can cause structural damage and foster mold growth, particularly on substrates susceptible to moisture damage.

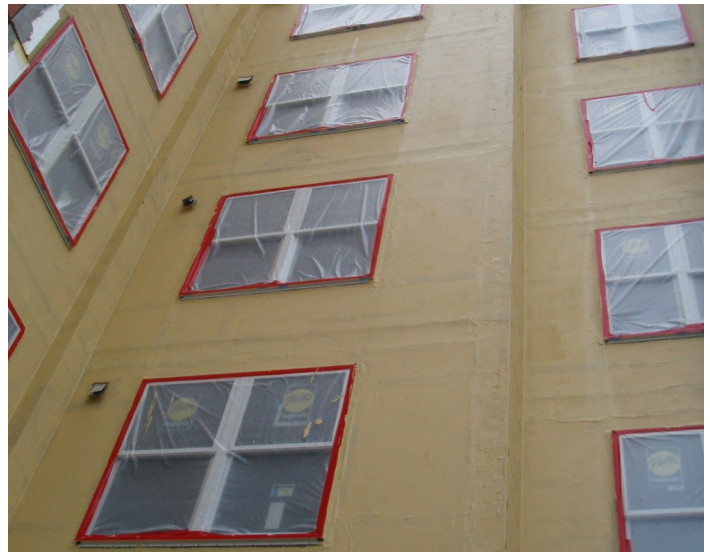
Construction of a drained EIFS system. The wall is covered with an air and water resistive barrier integrated with windows, making the wall weathertight prior to applying the EIFS.

Modern EIFS is applied over a drained water-resistive barrier and are sometimes referred to as drained or drainable EIFS. This system is typically adhered directly to the water-resistive barrier with vertical ribbons of thick adhesive that allow water to drain between the ribbons. Some systems use mechanically fastened insulation with vertical notches against the water-resistive barrier or a mesh drainage medium behind the insulation. When properly detailed and constructed, water penetrating the EIFS or sealants is stopped from entering the building by the water-resistive barrier and directed out of the system by means of flashings and weeps. Drained EIFS has generally overcome the barrier systems' shortcomings with respect to protecting the wall system from water intrusion and subsequent damage.
