INFLUENCE OF EDGE BEARING ON THE FRONT-EDGE SHEAR BREAKOUT CAPACITY

Neal S. Anderson^{1*} and Donald F. Meinheit²

¹Simpson, Gumpertz and Heger, Chicago, Illinois, USA

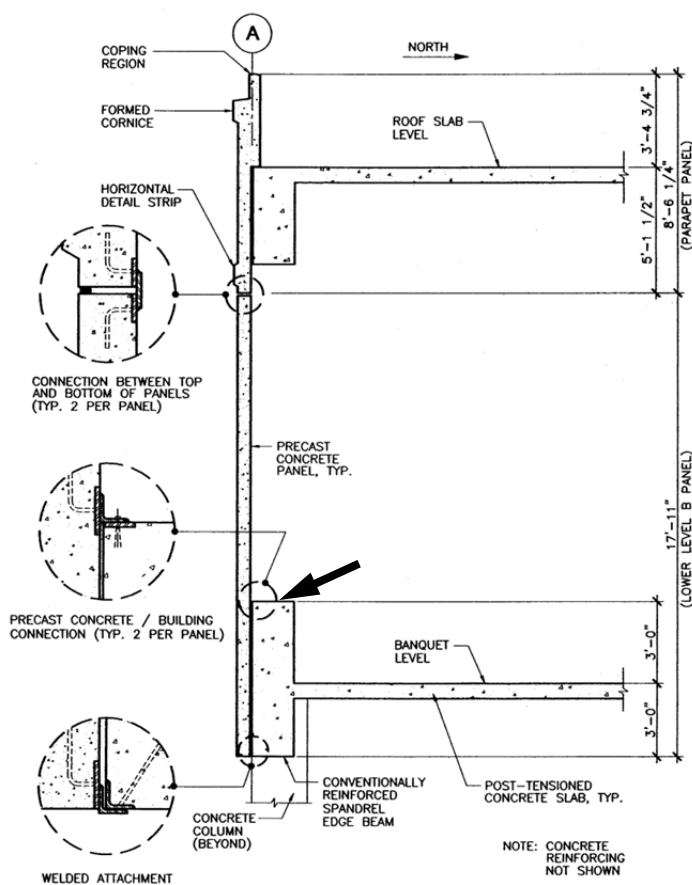
Figure 1: Cross section of cladding panel supported by a spandrel beam

In investigating the cause of a precast concrete panel falling off a hotel facade in the Midwest United States, we uncovered an interesting behavior of the panel connection. The panel-to-structure connection, shown in Figures 1 and 2, applied the panel gravity load to a spandrel beam. The connection consisted of an angle bearing on a steel plate, attached to the top horizontal surface of a

spandrel beam, with expansion or post-installed concrete anchors. The anchors were installed at a point atop the spandrel beam, outside the reinforcement cage core. Our investigation of the connection shear capacity revealed a reduced shear capacity due to the gravity load bearing on the connection plate attached to the spandrel.

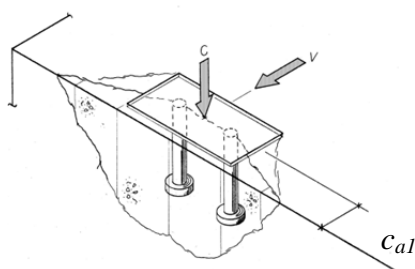
Figure 2: Loads on embedded anchorages in top of spandrel; see middle connection in Figure 1.
(C = Compression or bearing force, V = Shear)

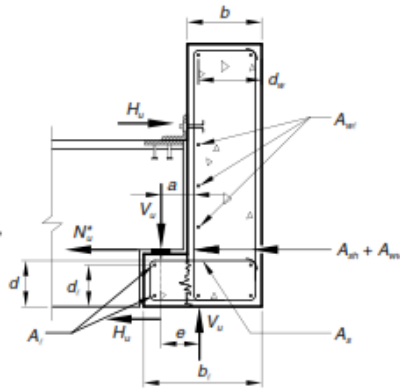
Figure 3 – Typical ledger beam supporting stems of precast double-tee members.

Other conditions like the one shown in Figures 1 and 2 exist when precast elements bear on supporting members. Two simple examples are the precast tee stems bearing on a ledger beam, Figure 3, and an inverted-tee beam or a stem of a precast tee beam bearing on a corbel, as sketched in Figure 4. In each of these conditions, the connection has a shear force applied toward a free edge due to time-dependent shrinkage or temperature deformations.

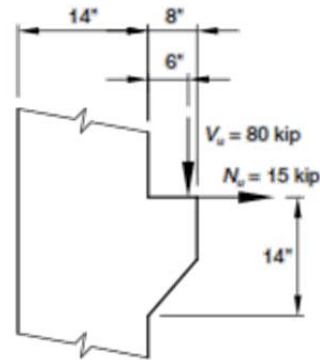
Figure 4 – Typical loading on a column corbel from an inverted-tee beam or precast double-tee beam stem (1 in. = 25.4 mm, 1 kip = 4.448 kN)

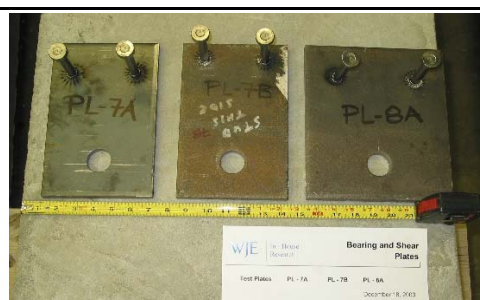
Table 1 – Steel plate dimensions for the anchorage tests

The steel plates used were 12.7 mm (1/2 in.) thick. Plate sizes are shown in Table 1 with a calculated bearing contact area of 15,490 or 20,650 sq. mm (24 or 32 sq. in.). The right-hand column of Table 1 shows the three plate configurations used. The plates had extensions that projected beyond the slab edge. As shown, the plate extension had a hole for a bolt and clevis assembly for the shear-load application.

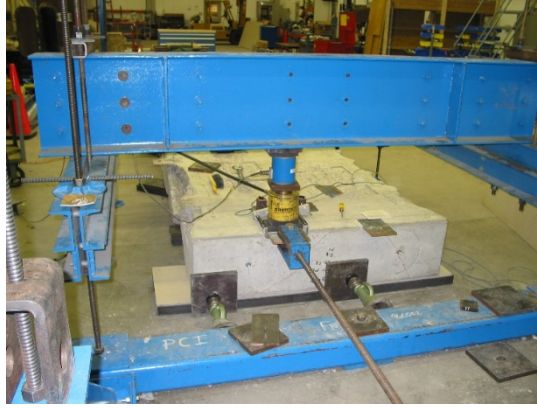
Figure 5 – Overall view of the test set-up showing both bearing and shear load application.

The anchorages were located at the edge of a 1.5 x 3.0 x 0.4 m (5 ft x 10 ft x 1 ft-3 in.) deep concrete specimen used for pryout testing for another experimental study. Tests were conducted by restraining the movement of the specimen. The simple loading apparatus and test slab is shown in Figure 5.

Figure 5 shows the test set-up. Each slab was tested flat, and the slab was rotated in-plane to access other embedded edge anchorages located on the sides. A test frame was built above the slab and tied down to the test floor for the bearing reaction. The shear test frame reacted near the ends of the slab edge, as to be located outside the potential breakout cone that forms along the long-edge direction of the test specimen. Test loads were applied with a manually operated hydraulic ram and loads were measured with a load cell. Displacement instrumentation, was measured continuously during the test to failure. After the failure, the characteristics of all concrete breakout surfaces were documented.

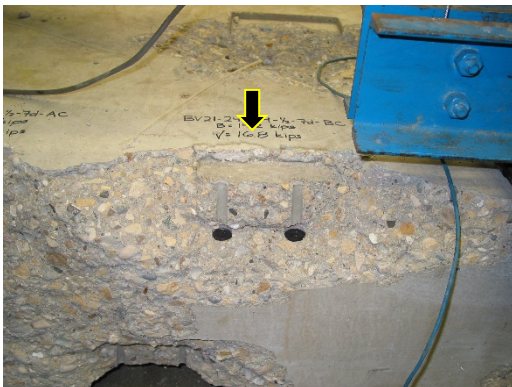
Figure 6 – Test BV21-24-6.4-1/2-7d-BC with a bearing stress of $0.1f'_c$.

Low Bearing Stress – These tests involve those with targeted bearing stress levels of $0.0f'_c$ (pure shear), $0.1f'_c$ and $0.2f'_c$. The two, pure shear tests were typical shear breakout surfaces and served as calibration tests. For tests with target bearing levels of $0.1f'_c$ and $0.2f'_c$, the shear capacity developed was greater than the no bearing load condition. Figure 6 shows the breakout with a nominal bearing stress of $0.1f'_c$. The concrete breakout surface was deeper and the entire shaft length (depth) of the stud was exposed; the entire stud length formed part of the final failure surface. (*Note in all the photographs, the stud head impression in the concrete was colored with a **black** marker, post-test, for reference.*) Instead of the top one or two diameters of the stud bearing on the concrete, it appeared the compressive confinement of the bearing load activated more stud length in resisting the shear force.

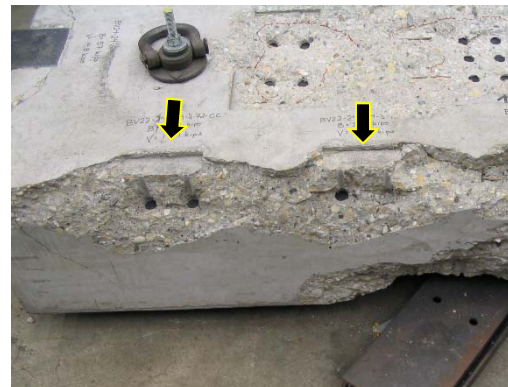
Figure 7 – Overall view of two shear tests with a $0.2f'_c$ bearing stress.

Figure 7 shows two test breakouts where the bearing stress was $0.2f'_c$. Again the breakout was deeper and had a vertical back face. In addition, the breakout started to activate a second crack front propagating at the rear of the plate. This is illustrated better in Figure 8, looking down at the breakout. Again, the shear capacity of the anchorage exceeded both the test sets with $0.0f'_c$ (pure shear) and $0.1f'_c$ bearing levels.

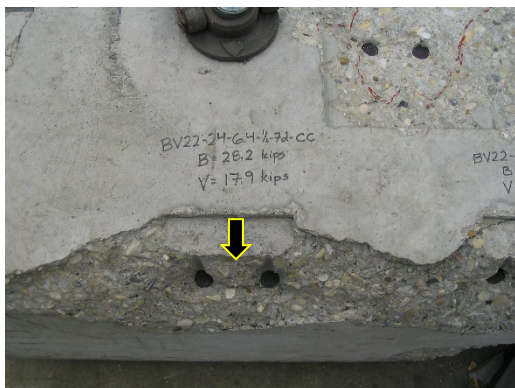
Figure 8 – Test BV22-24-6.4-1/2-7d-CC with a bearing stress of $0.2f'_c$.

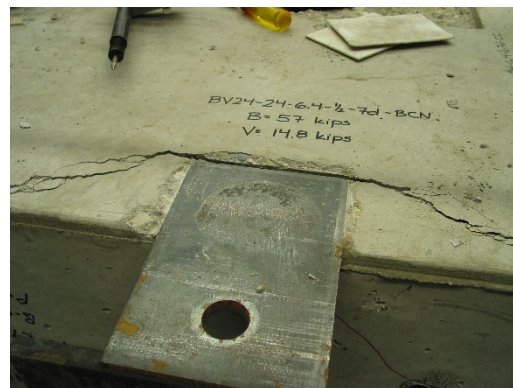
Figure 9 – Test BV24-24-6.4-1/2-7d-BCN with a bearing stress of $0.4f'_c$.

Figure 9 illustrates the failure crack at ultimate load with a $0.4f'_c$ bearing stress. Note the crack propagation around the back edge of the plate. The higher bearing load activated a failure surface more representative of a bearing-type failure; the whole plate area was a contributor.

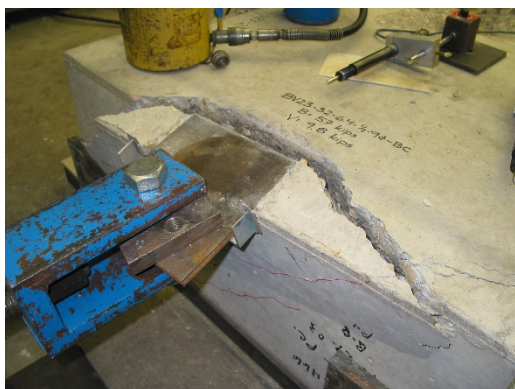
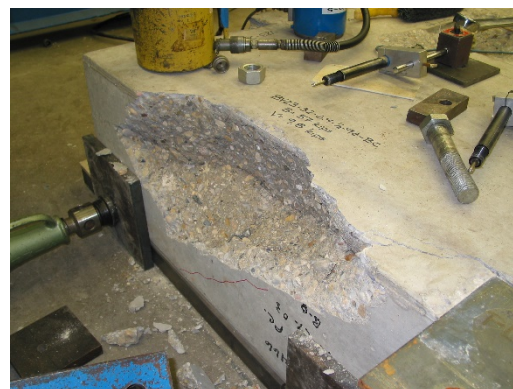
Figure 10 – Test BV21-24-6.4-1/2-7d-BC with a bearing stress of $0.3f'_c$.

(a) Breakout showing the development of the rear crack behind the anchor plate. The studs are contained in the breakout concrete.

(b) Breakout concrete removed showing the vertical rear crack surface to a depth lower than the studs. The studs did not intersect the crack failure surface.

Figure 10 is a similar situation for a target $0.3f'_c$ bearing stress level. The failure crack propagated around the back edge of the plate (Figure 10(a)), and resulted in a fairly large shear breakout cone. Upon removal of the concrete piece in Figure 10(b), the failure surface revealed a sharp, vertical face corresponding to the rear crack face. The entire stud anchorage was buried in the breakout piece and the studs did not contribute to forming the breakout crack surface. The vertical face was approximately the depth of the headed studs. Edge bearing of the concrete seemed to be the dominant action.

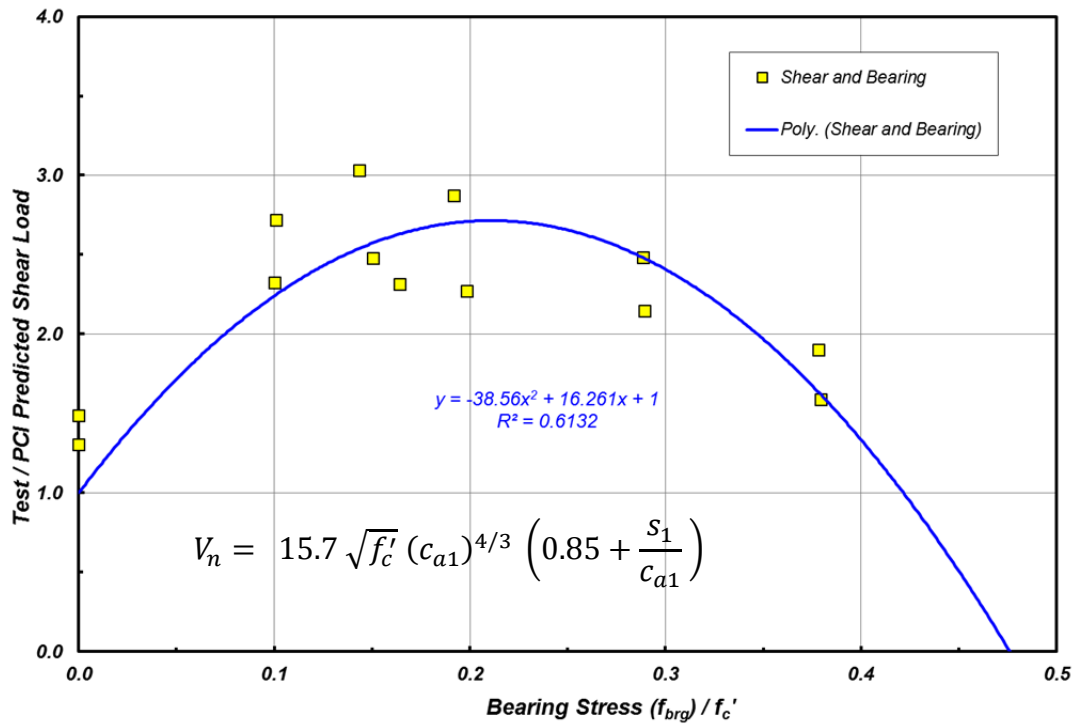
Figure 11 – Test-to-predicted (average) shear failure load (PCI) versus the bearing stress level expressed as a function of the concrete compressive strength.

Figure 11 shows the experimental behavior expressed as the test-to-predicted capacity versus the bearing stress referenced to the actual concrete compressive strength. The shear capacity was predicted with the average PCI shear equation using the PCI spacing factor for the two-stud pattern. The figure implies a beneficial effect of the bearing load on the connection up to f_{brg} / f_c' of about 0.42. For bearing stress levels, f_{brg} / f_c' of 0.1 to 0.3, the anchorage shear capacity increased and in some instances doubled (2x). As we observed during the testing, the peak effect seemed to occur around $f_{brg} / f_c' = 0.2$. Above that level of bearing stress, the improved shear strength diminished as the bearing behavior governed at the higher bearing load(s).

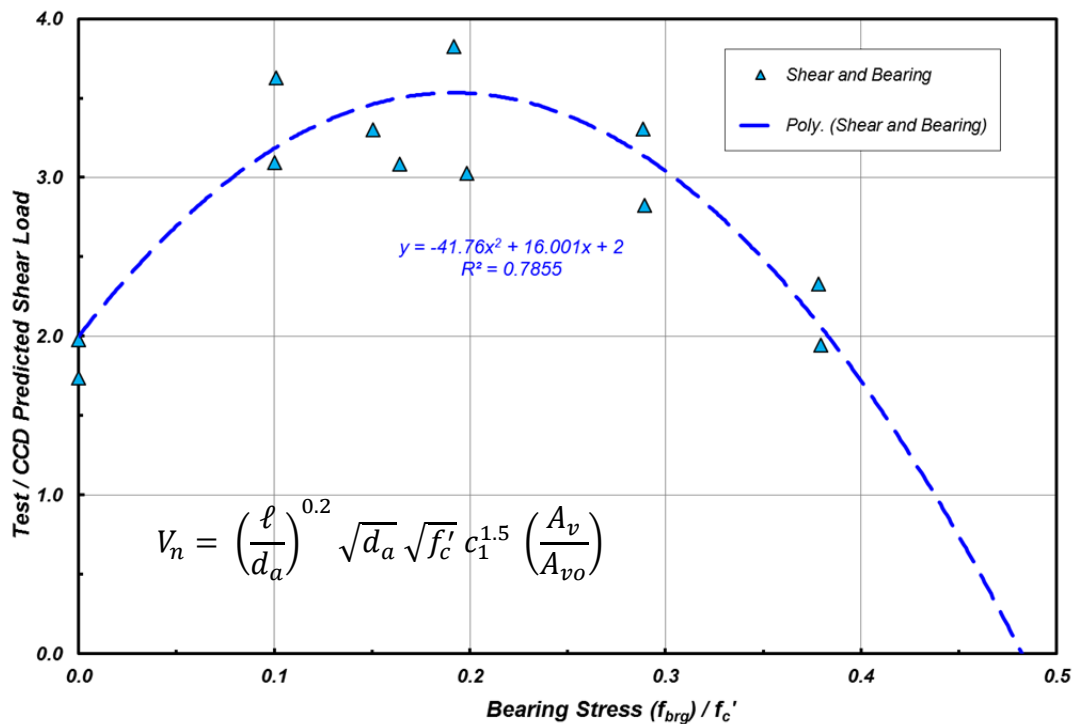
Figure 12 – Test-to-predicted (average) shear failure load (ACI-CCD) versus the bearing stress level expressed as a function of the concrete compressive strength.

The average concrete capacity design (CCD) shear prediction from Chapter 17 of ACI 318-14 is shown in Figure 12. The data trend of the plot is similar, but generally shifted upward for the headed studs. This demonstrates the CCD method is conservative when the edge distance is small (51 or 76 mm) and the spacing influence for the two-stud group is factored into the strength calculation for this close edge distance.
