ASSESSING THERMAL PERFORMANCE WITH sUAS AND DRONE TECHNOLOGY

By Christopher Grey, Kelsey Dunn, and Sean Gordon

30 MARCH 2023

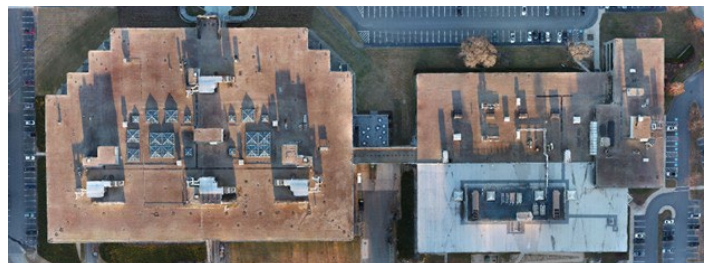
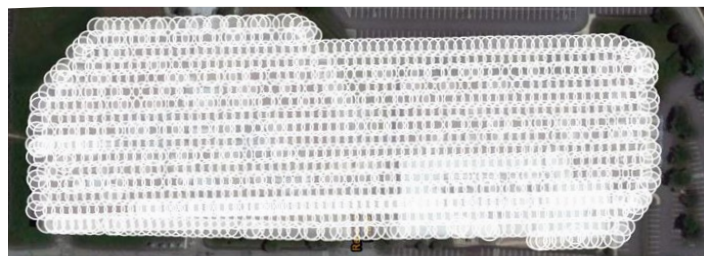
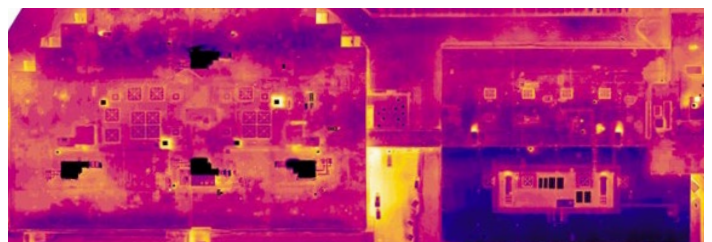
IMAGES Digital image of a subject roof fully stitched together from drone footage (top); Individual drone image collection, with each circle representing one photo (middle); Fully stitched digital infrared image of roof (bottom)

Quality of Data, Ease of Analysis: The quality of data and deliverables provided by an sUAS infrared scan is generally superior to what handheld infrared camera scans produce. Capturing larger areas of the roof in individual or stitched images allows design professionals to see a holistic infrared view of the roof that can be easily analyzed to identify larger patterns, which are more difficult to discern when reviewing many individual images.

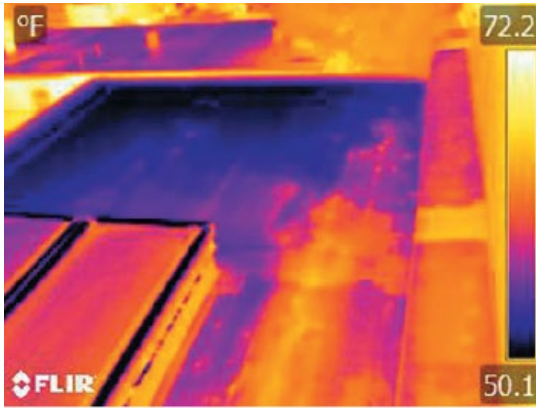
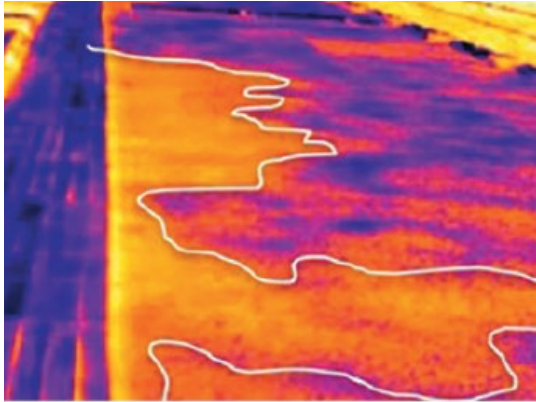
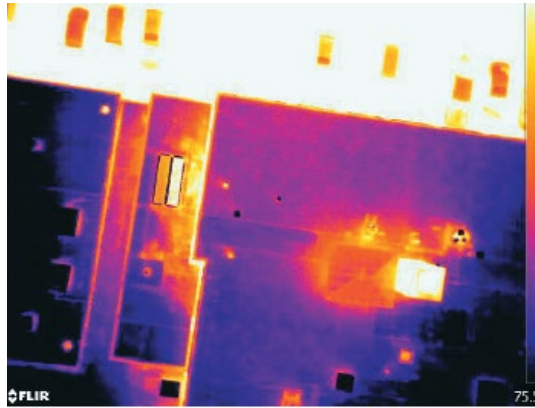
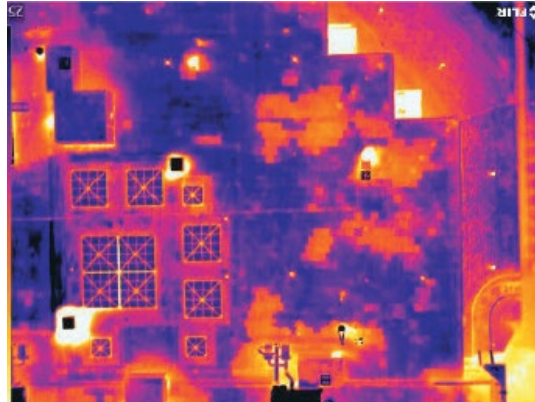
IMAGES Infrared images from a handheld camera (top left) and an sUAS-mounted camera (top right); Infrared images of a ballasted roof from a handheld camera (bottom left) and an sUAS-mounted camera (bottom right)

Aggregate Ballast Roof Systems: The thermal patterns associated with aggregate ballast over roofing membranes are often indistinguishable from “hot spots” associated with areas of wet insulation. sUAS images can display a larger area, which can mute localized anomalies and reveal more widespread issues.

Reflections: Infrared images are most accurate when taken looking directly perpendicular to the surface being scanned to avoid reflections from adjacent surfaces that can mask thermal anomalies associated with water or air leakage. Comparatively, an sUAS-mounted camera offers greater flexibility to take photographs from various distances and angles.
