THE SCIENCE OF FIREPROOFING IN CONSTRUCTION

By Melissa Roth and Emily Norwine

24 JUNE 2025

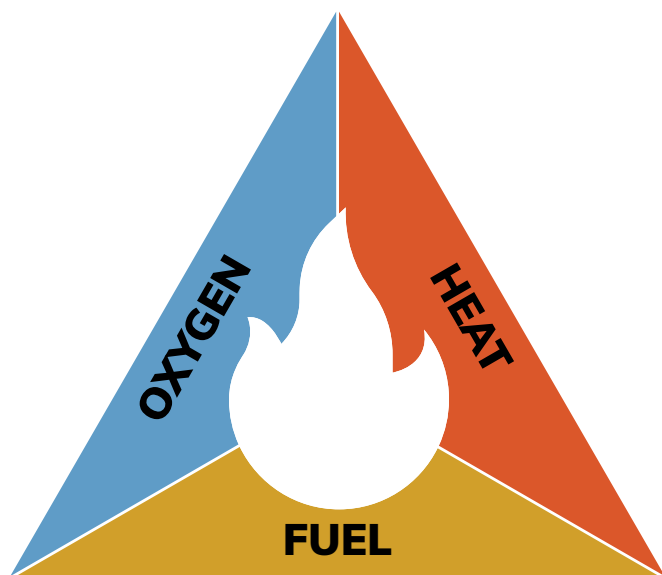
The fire triangle shows the three essential elements needed to ignite and sustain a fire.

A fire needs three things to start and continue burning: an ignition source, fuel (something to burn), and oxygen. Fireproofing works by disrupting one or more elements of this fire triangle by insulating the fuel to slow heat transfer, producing gases that dilute oxygen, or undergoing chemical reactions that prevent ignition or slow the spread of flames.

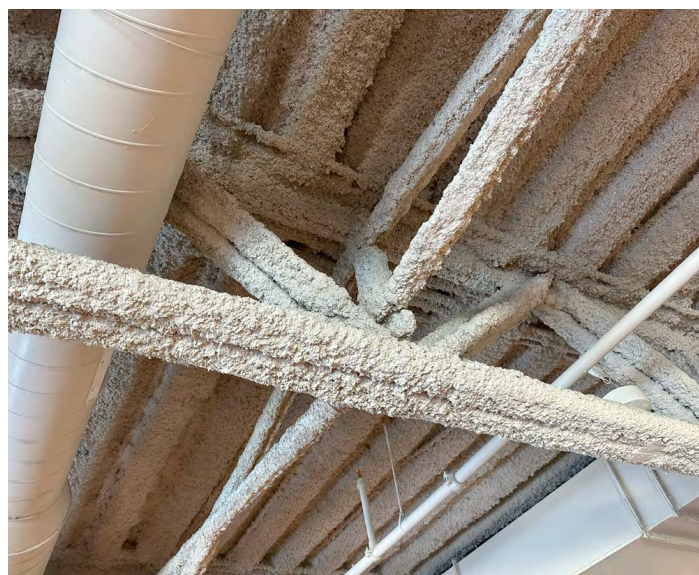
SFRM on structural steel beams.

Spray-applied fire-resistive material (SFRM) might be the first thing that comes to mind when thinking about fire retardants in construction. These are available as a wet or dry formula that can be sprayed or troweled onto a surface that needs to be protected. They are often applied to primary structural steel and horizontal assemblies to protect them from heat in the event of a fire. SFRMs are typically a gypsum or Portland cement mix that hardens into a foam-like texture.

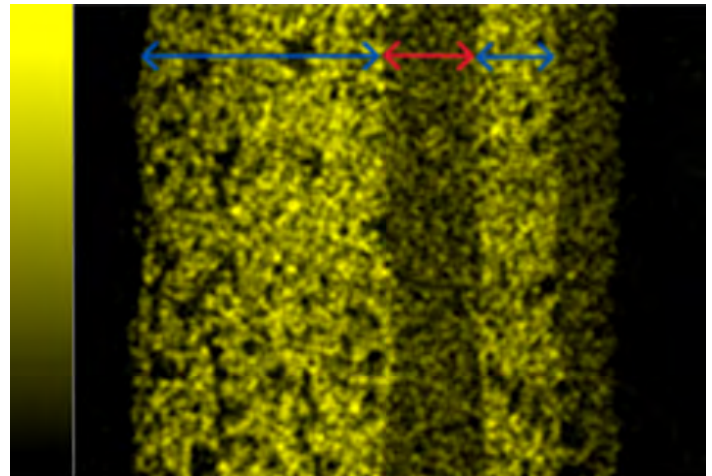
SEM of SFRM layers where yellow is a map of the amount of titanium present.

In a recent project, our engineers performed adhesion tests in the field and sent SFRM samples to the ASRC for failure analysis. Scanning electron microscope (SEM) imaging of the SFRM showed the presence of multiple layers of material, each varying in thickness, and containing different quantities of additives that we would expect to see based on the SFRM material's safety data sheet.

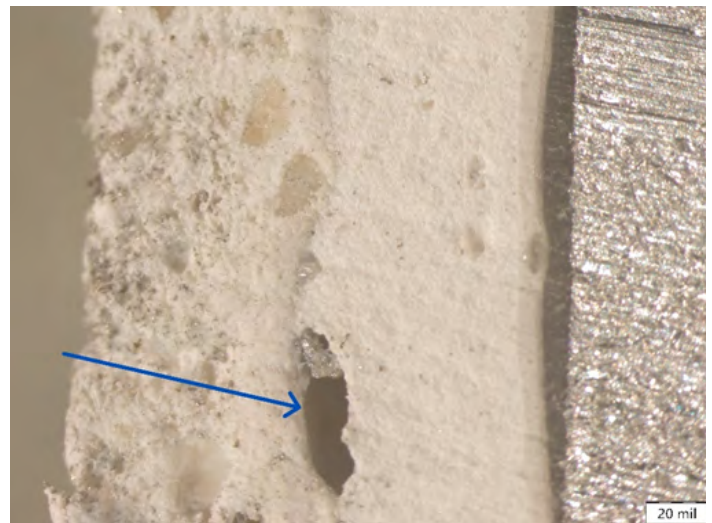
Nonuniform cavities in SFRM as seen through a stereomicroscope.

Using a stereomicroscope, we also found cavities and defects in between layers, which were nonuniform in size and distribution. We also observed that when the material was exposed to water, it became soft and malleable, leading to potential warping and cohesion failures that were observed in the field.

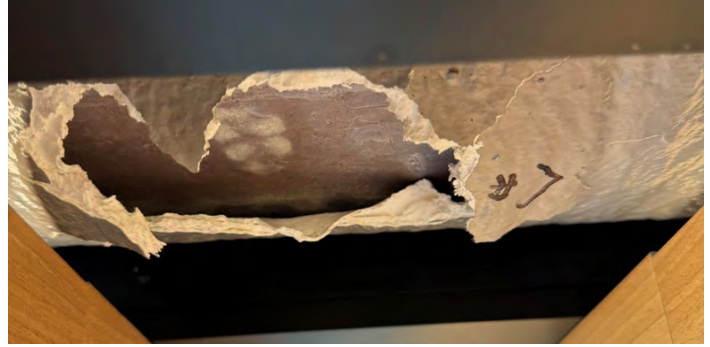
Peeling SFRM discovered in the field.

Fire-retardant coatings can fail in several ways, and it is not always obvious why. In these cases, it is important to document conditions and test material samples to explore what may be happening. For example, SGH's ASRC has seen several projects where SFRM was peeling and blistering, prompting our teams of engineers and scientists to investigate.

Using these laboratory analyses, we suggested several root causes for the material failure:

- I Improper mixing and material preparation before application, which led to adhesion and cohesion issues.
- I Water infiltration beneath the SFRM and/or high humidity conditions, which compromised the integrity of the SFRM.
