Cutting Prestressed Concrete Framing

Design and Construction Considerations

By Michael F. Hughes, P.E., S.E., and Sal A. Capobianco, P.E.

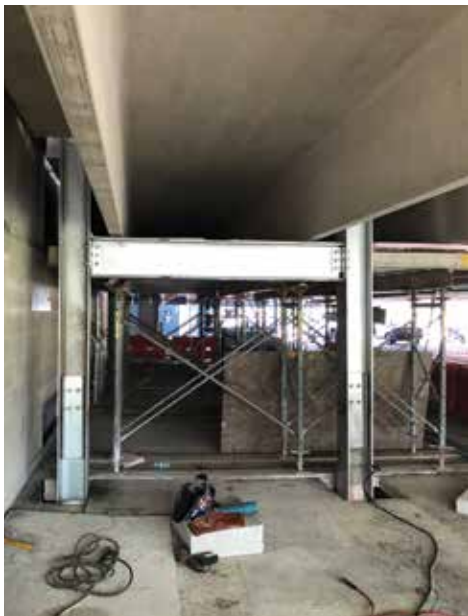
Figure 2. Steel support framing installed prior to demolition. Shoring towers for the portion of the PC framing to be demolished can be seen in the background.

The portion of DT to remain was supported on a new steel frame (*Figure 2*). The new steel columns were founded on new shallow foundations and laterally attached to the DT at each level for frame stability. The bottom of the new foundations was set at the same elevation as the existing garage and building foundations to avoid surcharging those foundations. The existing diaphragm connection of the DT to the braced frame would also be removed as part of the demolition; therefore, new horizontal steel bracing was added to connect the remaining diaphragm to the LLRS (*Figure 3*).

TRG installed the steel frame by cutting localized openings in the flanges for the columns to pass through and then installing the beams under the DT stems before removing the DTs. The full portion of the DT was removed in sections at night, and the garage remained operational during the day. The DT was shored using standard shoring frames, aluminum beams, and plywood to create a combined shoring platform and debris shield at each level, and was supported on grade. Demolition started at Level 6 (roof) and proceeded downward. Five levels of DTs were cut and removed. *Figure 4* shows the demolition progress at Level 4. The Contractor reported that they did not hear any popping sounds consistent with strand slip and no new distress was observed. Once demolition began, it took the TRG approximately three days to remove the portion of the DT at each level. The demolition work went smoothly and was considered a success by all parties.

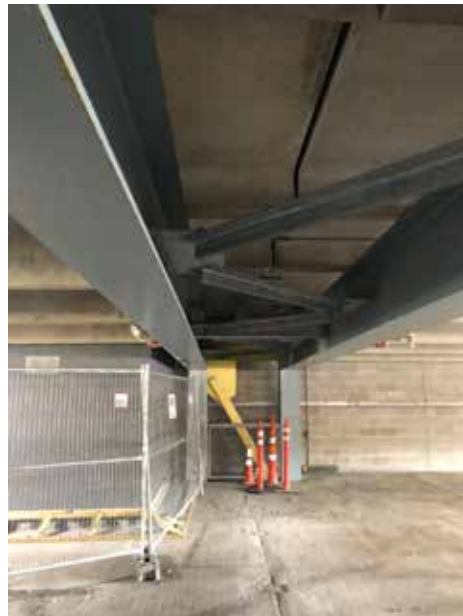
Figure 3. Supplemental horizontal steel bracing to the restore diaphragm connection to LLRS.

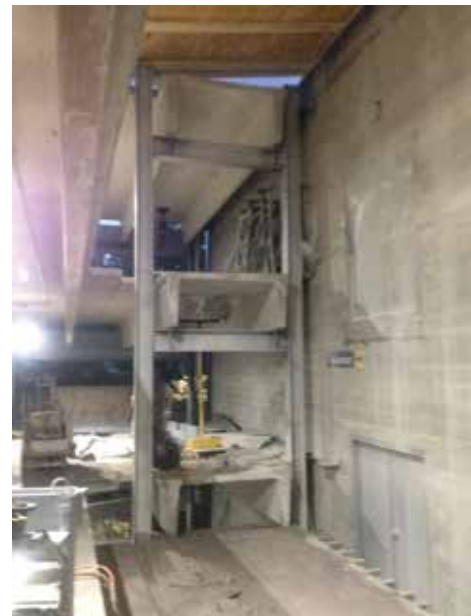
Figure 4. Top 3 levels of PC DT framing demolition immediately after removal at Level 4. Courtesy of The Richmond Group.
