# EVALUATING BUILDING ENCLOSURES AFTER HURRICANES

By Eric Olson and Peter Nelson 9 AUGUST 2022

## **BUILDING ENCLOSURES AND HURRICANES**

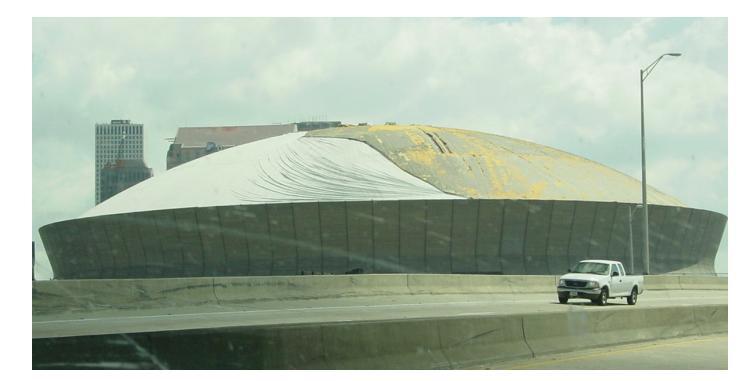
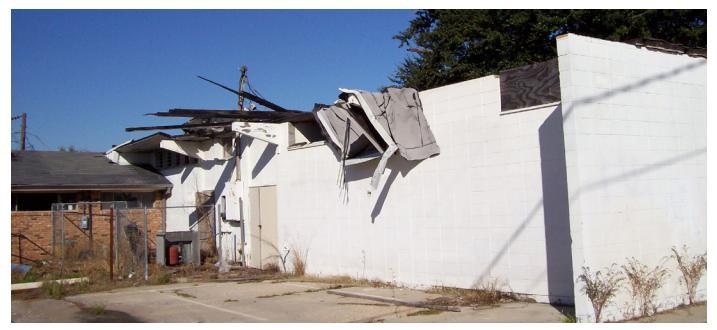
Hurricane-damaged roofs

Wind damage to the roof covering system (e.g., asphalt and tile shingles, metal panels, and low-slope roofing membranes) during a hurricane is often caused by uplift forces or impact from windborne debris. The resulting damage can allow water leakage into the building. Many roofing warranties exclude damage caused by winds well below typical wind-design criteria found in modern building codes. The roof's age, quality of original installation, maintenance history, and preexisting deterioration can also affect the roof's performance during a hurricane.

Wind creates uplift loads on roofs. If these forces exceed the strength of the covering or its attachment, the covering may detach. The highest uplift pressures typically occur at roof corners and edges, so these zones can be more vulnerable to uplift failures. Loss of roof coverings can lead to catastrophic water intrusion.

Roofs are also susceptible to damage from impact due to flying debris or from roof-mounted equipment displaced by wind. Even small punctures in the roof covering can lead to water leakage during heavy rains associated with a hurricane, particularly if damage occurs in pond-prone areas or if roof drainage is overwhelmed by heavy rain. Following these events, roofing systems should be carefully inspected and checked for evidence of impact damage, detachment of roof coverings, and flashing deficiencies that can lead to water leakage. Prompt patching of openings by a contractor, even on a temporary basis, must be performed to prevent additional damage. Trapped moisture can degrade materials over time, which may negatively affect the roof's performance during future events and reduce its thermal performance. Post-hurricane assessment and identification of wet materials concealed beneath the membrane can help building owners plan for repairs that can prolong the roof's service life and help insurers determine the extent of roofing damage as needed to assess the validity of claims and quantify covered losses

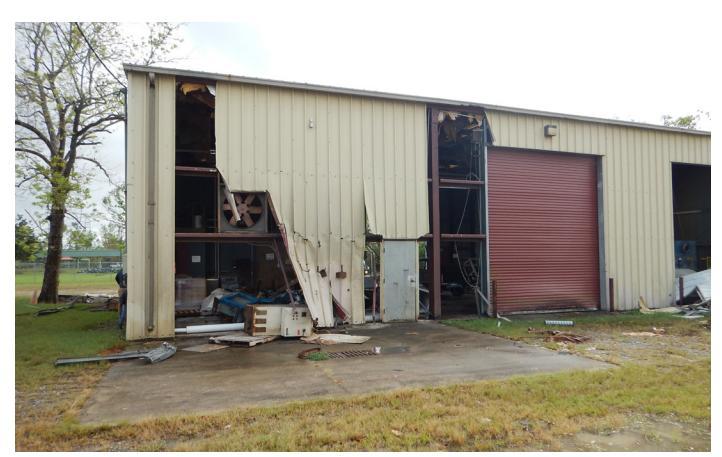
Hurricane-damaged walls

Facade and Fenestration Damage from Winds and Leakage Exterior walls and windows can also be damaged by flying debris or wind pressure, resulting in cladding loss, glass breakage, or weakening of system attachments. These issues can also lead to water leakage into concealed wall spaces or the interior. If the building loses window or curtain wall glass, it can experience increased internal building air pressure due to wind forces, which can contribute to structural, roofing, or interior wall damage.

Although leakage through the facade can occur due to structural or impact damage, it can also occur at wind pressures significantly lower than those needed to cause structural damage to the building or these systems. Such leakage can occur even without system damage if wind pressures during periods of heavy rainfall exceed the cladding or fenestration systems' design for water infiltration resistance. If the leakage paths are concealed within the systems or surrounding construction, it can be difficult to find and repair the leakage sources without a detailed investigation.
